SAVE THE YANKEE GATE 2 COMMITTEE

Information Update: September 3, 2009

GATE 2 ORIGINALITY

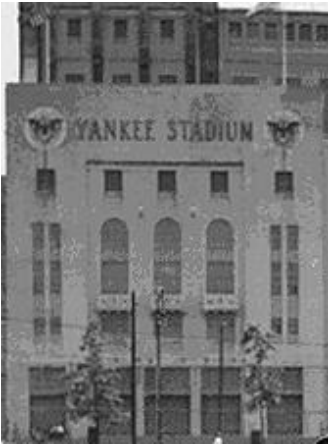
Gate 2: 1928-1973

The exciting reality is that more than 80% of the original 1920's Gate structure remains. Of the stadium's three main entrances, Gate 2 was the only one not significantly altered during the renovation, and we believe that Gate 2 is the most architecturally significant element remaining from the pre-renovated structure. Please refer to the three photos/renderings below that clearly illustrate this originality.

In terms of its construction, the lowest section of the Gate was built in 1923 when the stadium opened. The upper portion (arches & balconies) was added in 1928 with the leftfield grandstand extension. Because the upper deck was reconfigured during the Yankee Stadium renovation in 1973-76, the uppermost section seen in the old photo on the left (contains the two medallions and the Yankee Stadium lettering) was replaced with the concrete strip with the three vent openings and the cornice above as shown in the center post renovation photo. Our proposed Gate 2 restoration (depicted at right) would only involve the removal of the horizontal concrete strip located above the cornice (refer to center photo) and reinstalling the two medallions and the Yankee Stadium lettering.

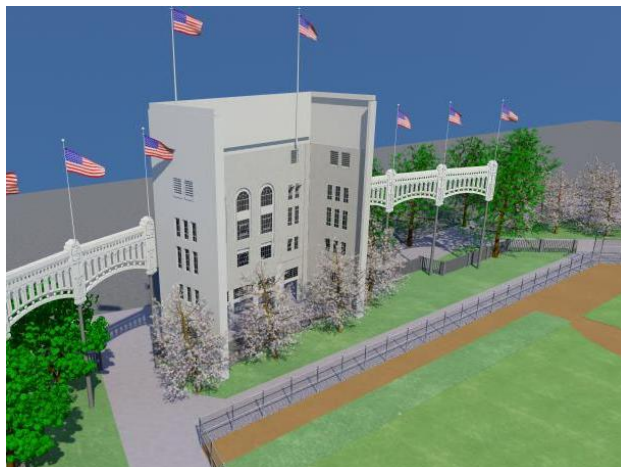
The two sidewalls would provide stability for Gate 2 as shown in the rendering below. The sidewall on the right (or current outfield side) was built as part of the 1928 grandstand extension. This wall still exists. So new construction would consist of just the one sidewall depicted on the left (or infield side) of this rendering.
